STS-107 Columbia Reconstruction Report

NSTS-60501

JUNE 30, 2003

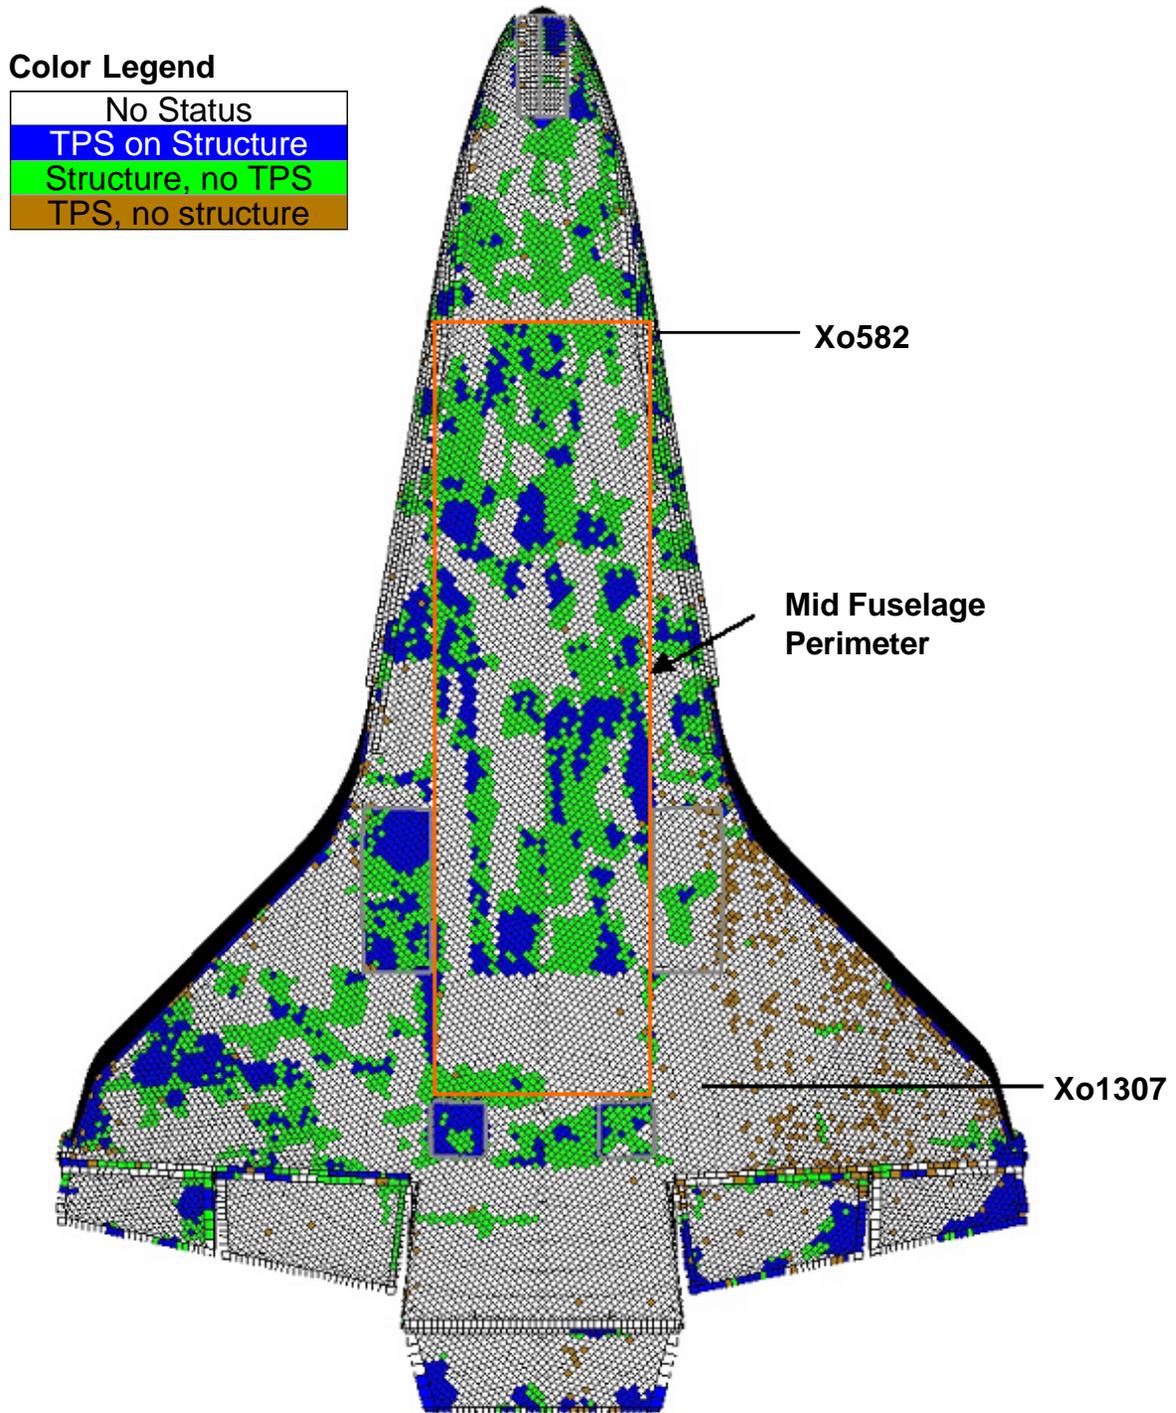
Figure 8.1 Recovered Orbiter Debris - Lower Surface

Cumulative tracking of recovered debris by OML location was accomplished graphically with an electronic mapping system. Figures 8.1 through 8.4 show the recovered OML debris as viewed from above, below, and both sides.

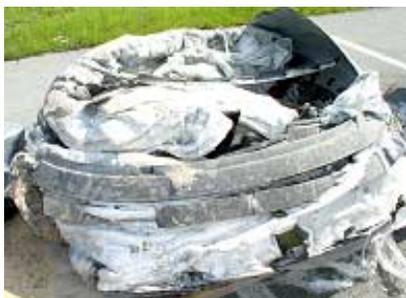
Item 1114

The recovered forward fuselage components are predominantly skin/stringer segments and include a few noteworthy subsystem components. The component size ranges from less than one square foot to approximately ten square feet. All observed components exhibit evidence of mechanical overload as the primary failure mechanism. With very few exceptions, heating plays an insignificant role in the component degradation and appears to be during or subsequent to the mechanical breakup. Roughly 40% of the forward fuselage has been recovered with no difference in damage levels comparing left to right or upper to lower. Two recovered RCC components, nosecap and chin panel (1114), show evidence of mechanical breakup with no thermal damage.

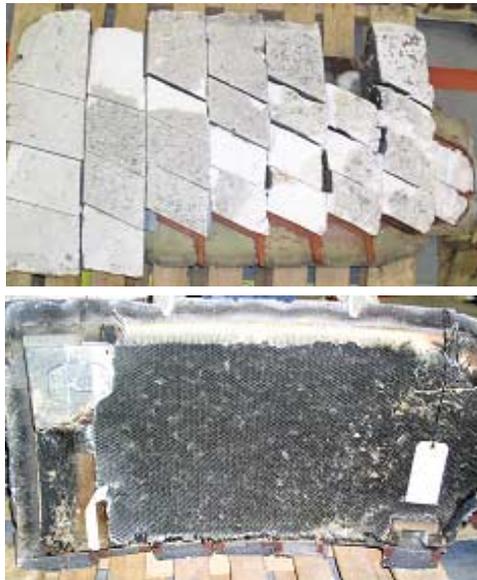
Item 284

Other OML components include the forward Orbiter/ET attach fitting with RCC

arrowhead (37046) and the forward half of the left hand nose landing gear door (Item 284).

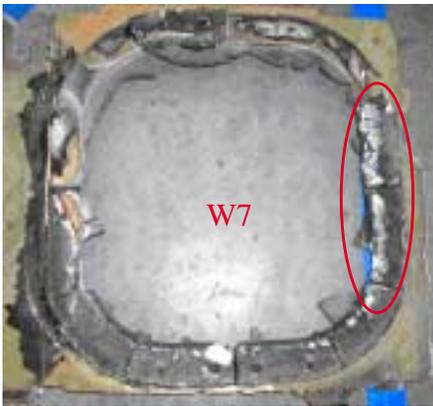
Item 1175

The overhead window carrier panel (1175) tile damage is unique in that the perimeter carrier panel tiles show outward slumping and glassification on all four edges

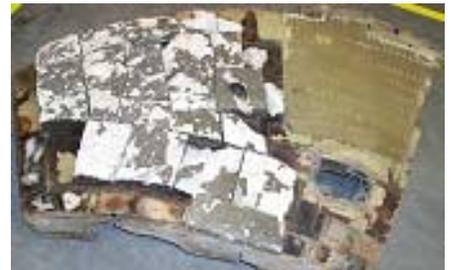
Item 2171

Three of the four crew module attach links (1678, 1765 and 2171) were recovered. Three of the four attach lugs for the links were intact, while the left hand lug was fractured.

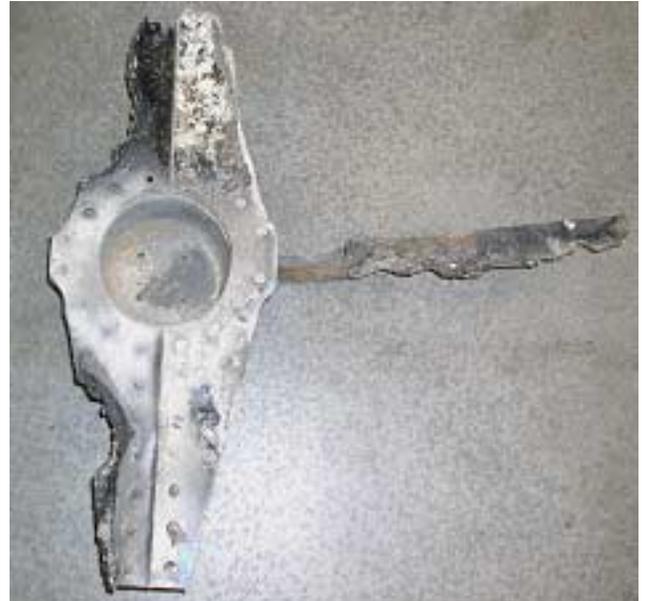
Item 32038

The left hand forward (32038) and right hand aft (49366) hoist fittings are significant due to ablation of the titanium.

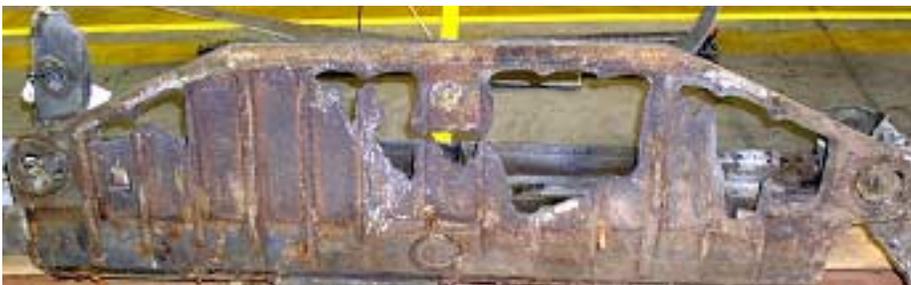
Item 266

floor. Fracture edges of the sidewall skin segments are generally less heat affected than those of the floor segments. For those locations where skins connect to the midbody main frames, the majority of failures occurred between skin and frame rather than within the frame itself. Very few frame segments have been recovered. Noteworthy components include heavily eroded titanium longeron bridge fittings (266).

Three sections (1 left hand and 2 right hand) of the sill longerons were recovered. The mid fuselage sill longerons (105, 266, 54117) are significant as they provide primary mid fuselage stiffness.

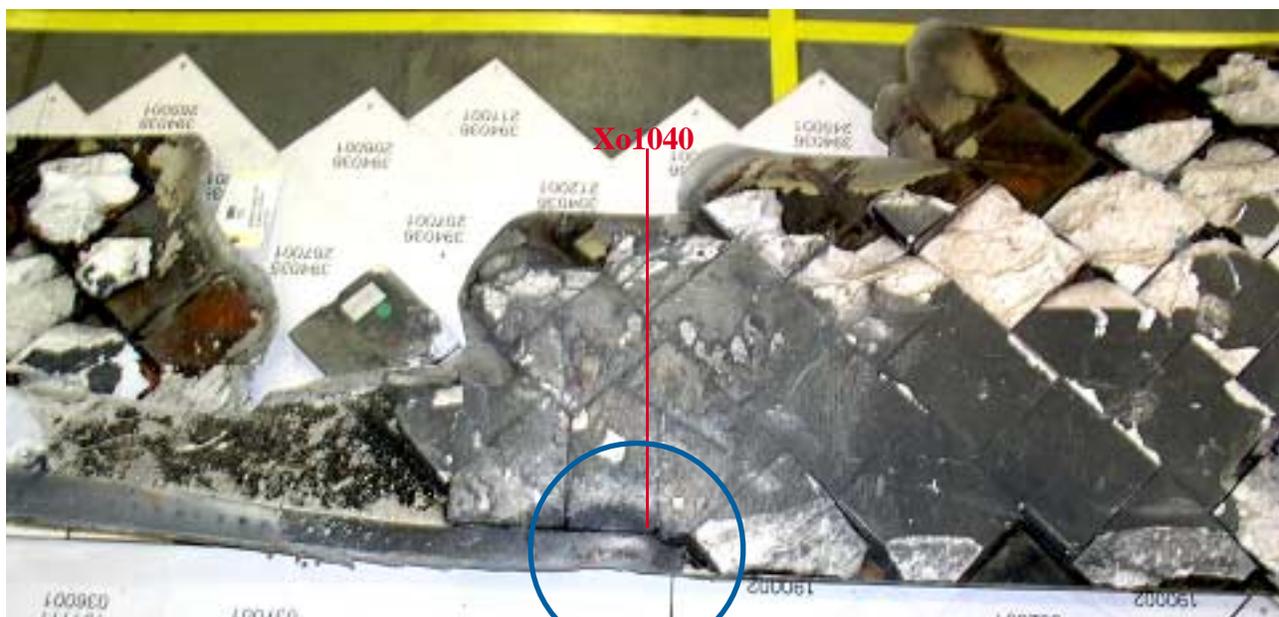
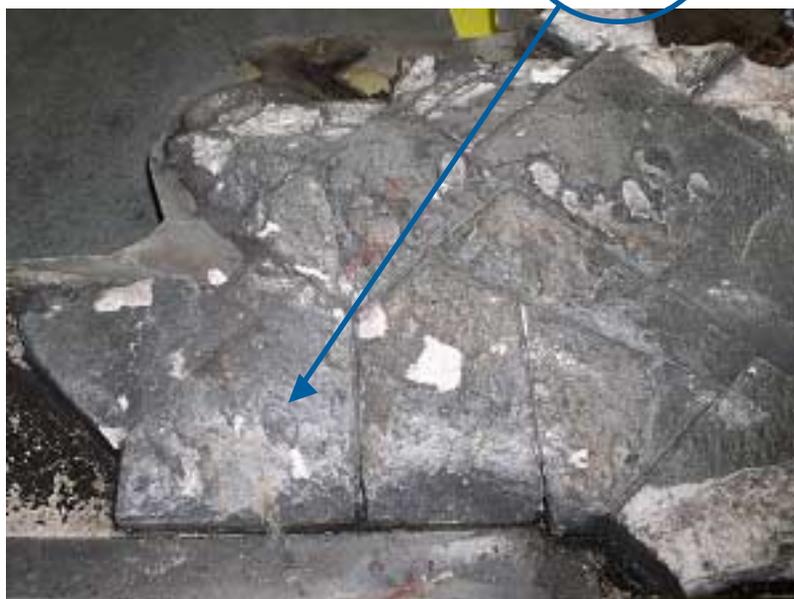
Item 283

The eroded skin panel (283) just inboard of the left hand wheel well, has outward plasma flow from the wheel well region. The point of erosion is located at the forward-inboard corner of the wheel well.

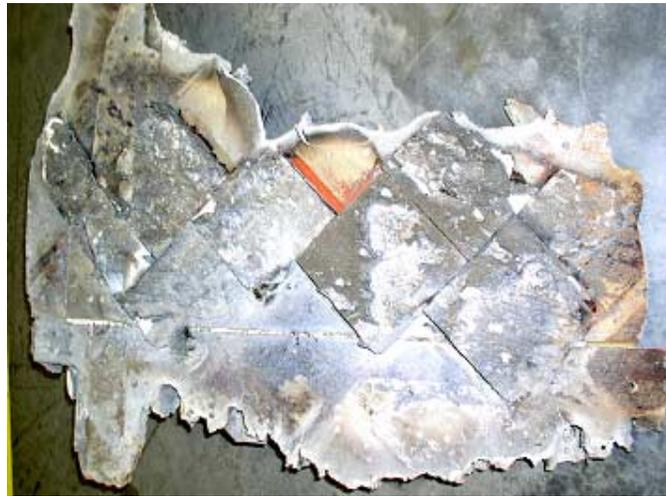
Item 53827

A few mid fuselage items have significant TPS slumping or glassification. An example is the lower wing root to fuselage attachment at Xo1249 (53827), and the inboard edge of the left hand MLG wheel well (9464) at Yo105.

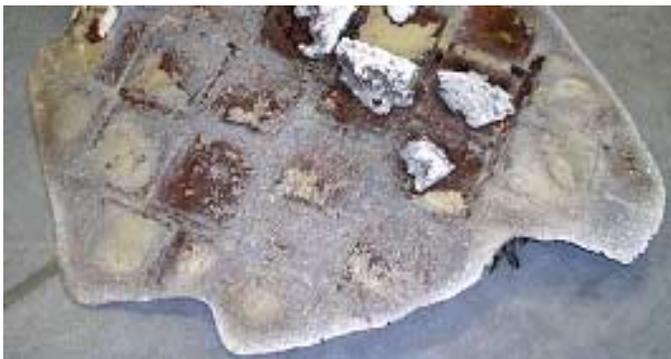
Item 52240

A few lower surface skin segments (52240, 1193) show heavy edge erosion. The aft inboard corner of the left hand wheel well where the Yo105 sidewall and the Xo1191 spar join, are two examples of this condition.

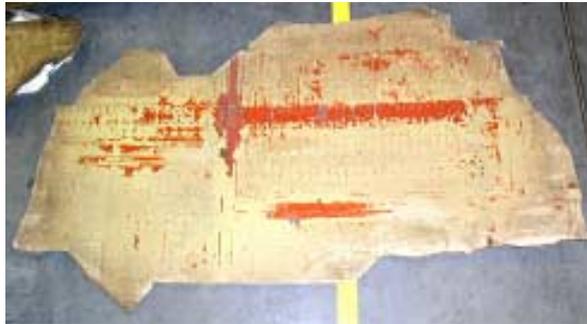
Item 38767

A typical fuselage sidewall segment (38767) has TPS erosion on the outer surface and fractured stringers on the inner surface.

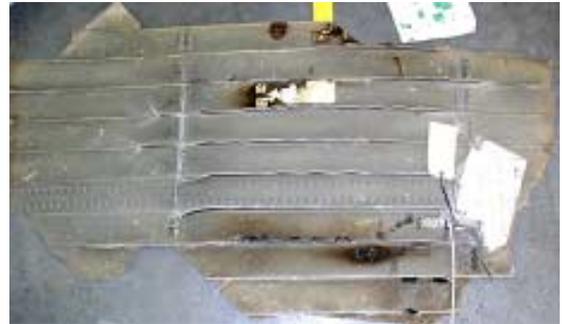
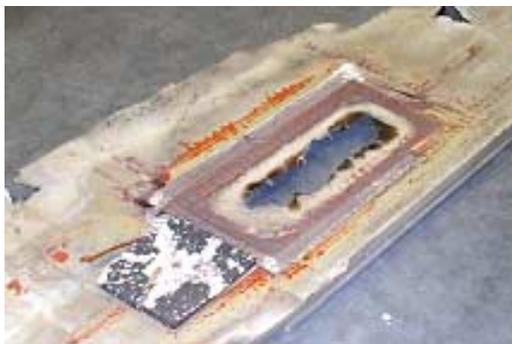
Item 25969

One item which shows localized heating damage is the vent door blanking plate (25969), which is part of the left hand midbody sidewall.

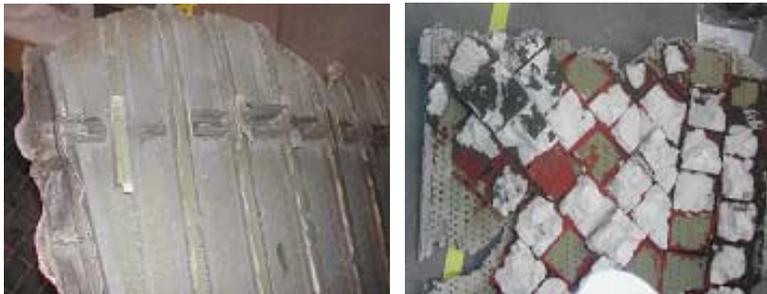
Item 8496

Right Hand Glove - Fifteen percent of the right hand glove upper and lower surface area was recovered. The upper pieces were mostly one to three square feet and located near the leading edge in the area where tile was installed compared to the lower glove area, which included one large skin piece (8496) that is approximately fifteen square feet. One upper skin piece included a portion of the Xw807 splice for the wing glove to mid fuselage fairing (12553). Structural wing

lower wing glove skin acreage (2113). This skin piece (2113) was comparable to a right hand piece that was approximately the same size and in approximately the same location with the left hand piece having more heat effects than the right hand piece (8496) on the IML and OML surfaces.

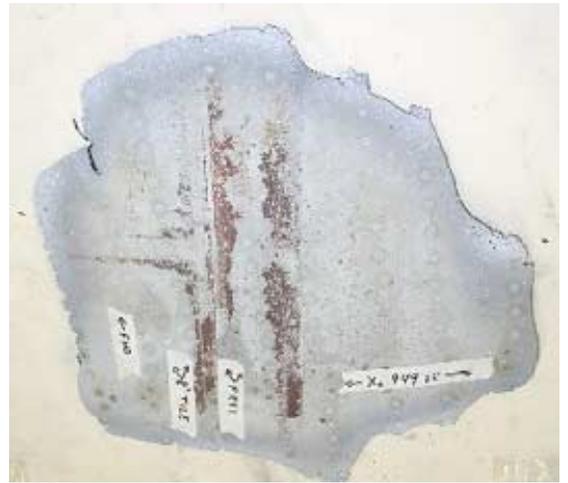
Item 33611

A piece of upper wing glove skin at Xw949 and Yw140 (33611) has overload fractures on the inboard and outboard edges and unique molten fracture surfaces on the forward and aft edges. The molten fracture edges are very porous, and there are tiny impact craters covering the entire part's IML and OML surfaces.

The OML surface has only a slight tile/filler bar footprint and the primer was missing on the IML and OML of this part. The location of this piece is inboard of a recovered left hand leading edge spar piece (83323) with RCC panel 2 upper-fwd attachment, which has medium slag on the IML side.

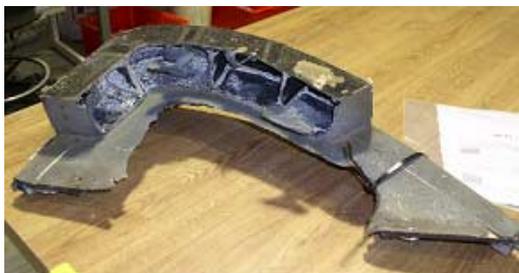
Item 24709

The glove honeycomb bulkhead piece (24709), which is forward of RCC panel 1, has more thermal damage on the aft side than the forward side. The four internal tiles on the aft side are missing and the FRSI in the four internal cavities is charred black. The forward side has more

eroded everywhere except where the structure is reinforced.

thermal erosion and slag than the aft side and the honeycomb bulkhead is thermally

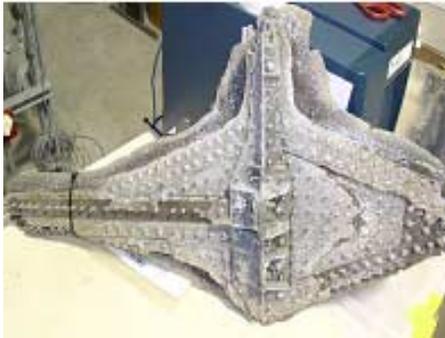
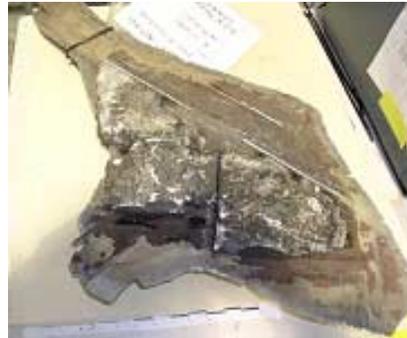
Item 68801

skin (68801) was recovered. This area was structurally reinforced because it is one of the wing assembly hoist points, consisting of a four-bolt pattern centered on the intersection. On this item there is medium slag build up, thermal erosion and broomstraw fractures. The entire surrounding upper honeycomb skin is completely eroded away on the edges with heavy thermal erosion on the aft-inboard hoist point fastener.

Although slightly smaller compared to a corresponding piece on the right hand wing (68801) there is very similar thermal erosion on the IML side with the left hand piece showing a heavier slag build up than the right hand. Additionally, both pieces have some shadowing effects on the forward side of the IML. The OML sides of the left hand and right hand pieces were similar with charred filler bar and/or tile fragments fractured at the densification layer.

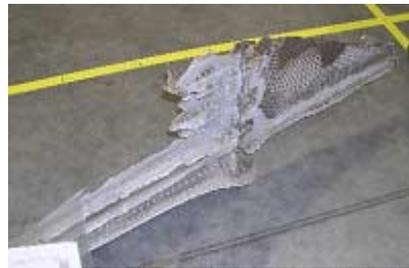
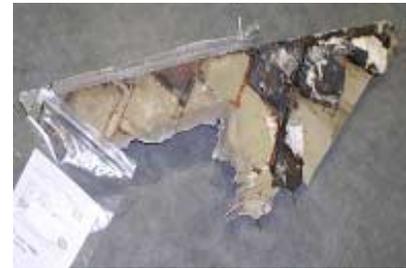
Item 14880

A lower skin to fuselage splice piece (14880) also shows thermal damage on the fracture edges, including broomstraw fractures and thermal erosion. A rib located at Xw1113 and Yw174 (75613) has medium slag build up and the exposed fasteners

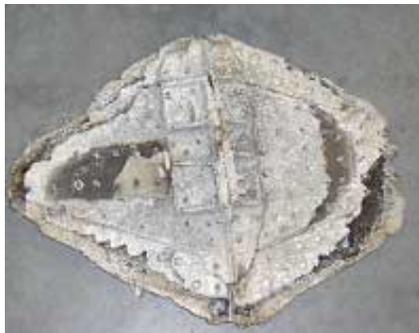
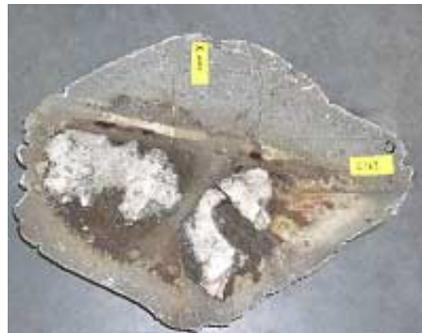
Item 67091

two small items are honeycomb skin splices at intersections of main spars and ribs less than one square foot in surface area. A lower Xw1040 spar, Yw167 rib intersection with attached wing skin (67091) is a structurally reinforced assembly hoist point and the entire surrounding upper honeycomb skin is completely eroded away on the edges.

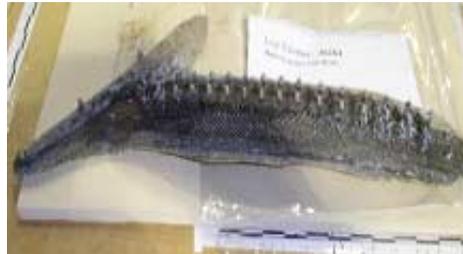
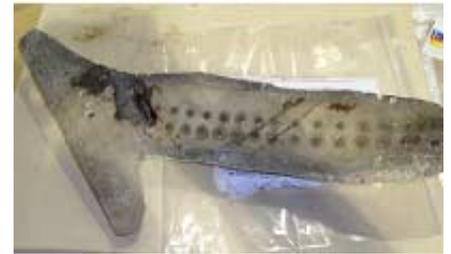
Item 43698

The lower intermediate wing is comprised of seven smaller items of honeycomb skin splices at intersections of main spars and ribs. Four pieces are located forward of the MLGD and three pieces are located along the outboard side of the MLGD. No other pieces were recovered in this area. The four pieces forward of the MLGD (74416, 43698, 40982, 41089) and the three pieces outboard of

the MLGD (50345, 49482, 24812) all have honeycomb facesheet and core erosion except for the areas along fastener rows where a potting compound was used.

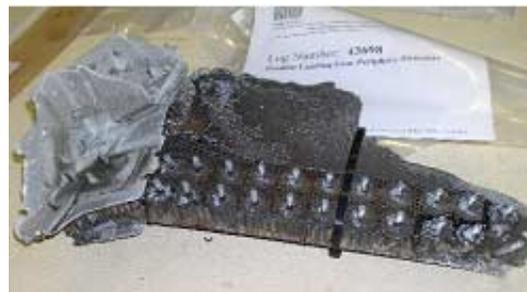
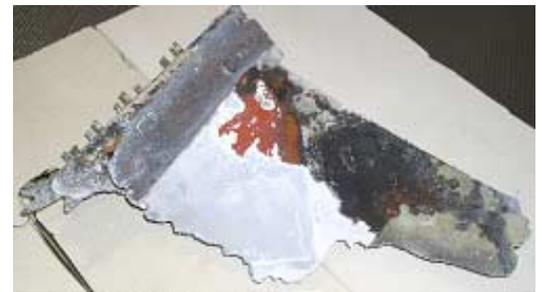
Item 36264

The other piece is the upper wing skin at Xw1160 and Yw282 rib at its intersection with the wing leading edge spar (36264) adjacent to RCC panel 13. The lower facesheet is missing and the exposed honeycomb core is

thermally eroded down to the potting adhesive used around the string of fasteners where the rib attached on the IML side.

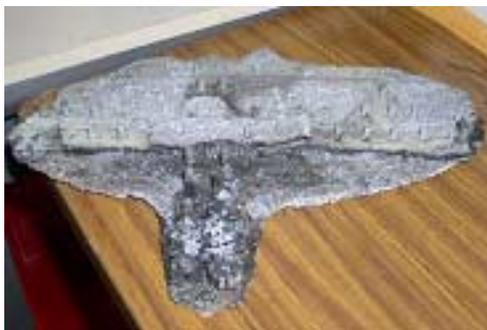
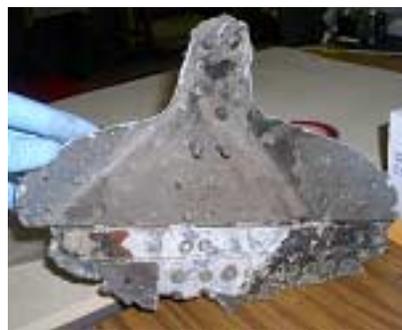
Item 24812

The three pieces outboard of the MLGD were more structurally reinforced than the four located forward of the MLGD and have more thermal erosion and slag deposits on the IML side. One of the pieces outboard of the MLGD is a small portion of the Xw1191 splice plate (24812) located outboard near the wing leading edge at Yw254, which has thermal erosion, and heavy slag deposits on the IML side.

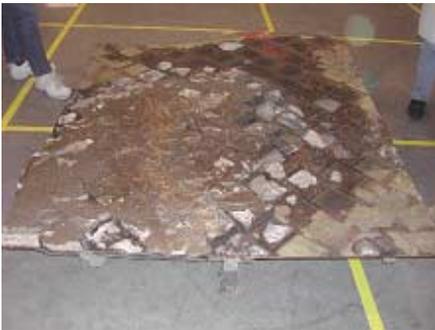
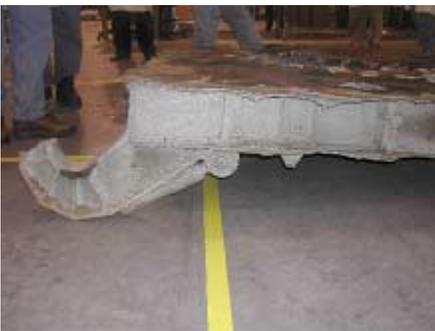
Item 658

The aft side of the forward piece of MLGD (658) has fracture edges in the lower skin immediately aft of the center hinges, which are deflected out-of-plane. The edge of this door piece has slag uniformly distributed across the entire surface, which is not present on any other edges of this piece or on any other edges of the aft door piece (260). The forward and center hinge fittings are fractured two thirds of the way along the fitting arc length and there are two intact up-lock rollers along the inboard edge, and one intact along the forward edge. The forward side of the aft piece of MLGD (260) has

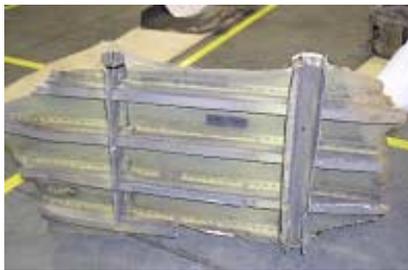
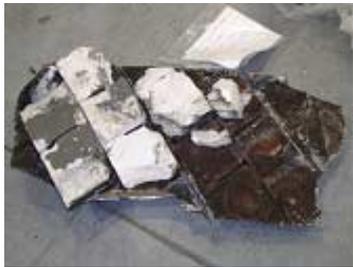
Item 16556

between Xw1249 to Xw1307, outboard of Yw312. The upper pieces (12213, 78275) and lower pieces (2071, 1446 and 16556) have stringers fully intact with no failures of the hat sections and little discoloration of the primer on the IML side of the skin. The OML of these five skin pieces has more tile remaining and less in plane fractures than the surrounding skin pieces.

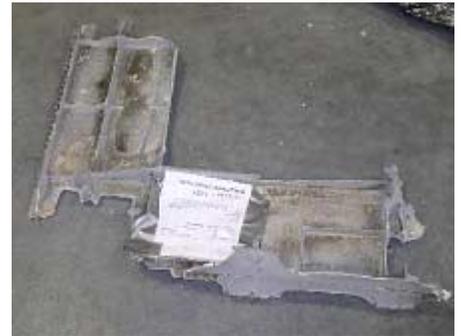
Item 41670

Only two identified pieces of internal wing spar at Xw1307 were recovered; the inboard (1421) and the outboard (41670)

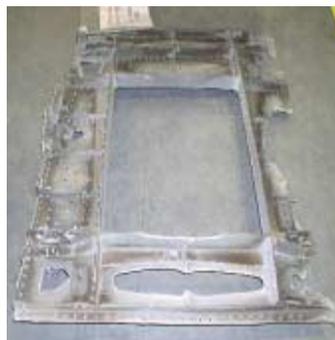
Item 1165

and a large piece of right hand wing honeycomb leading edge spar from Xw1307 to Xw1365 including pieces of the lower skin. The seven pieces of wing root between Yw105 and Yw123 (1165, 59401, 1550, 77707, 73025, 67930, 37309) include main spar attach bolts between Xw1191 to Xw1249 (59401), main spar attach bolts at Xw1307, and reinforced upper wing skin panels with stringer carry-through fittings (1165). All of these parts have broomstraw fractures and localized heavy thermal erosion.

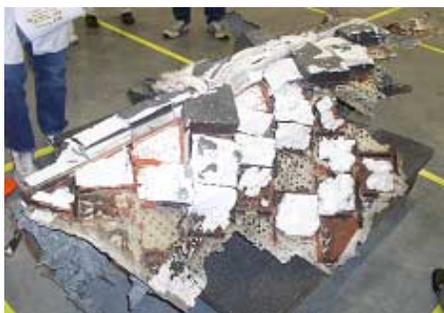
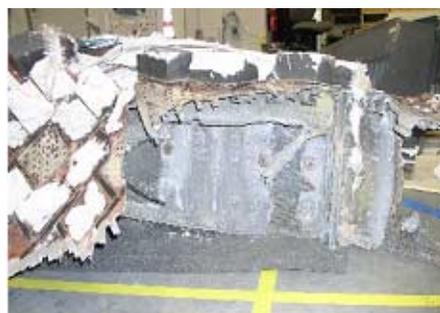
Item 59409

The piece of honeycomb leading edge spar (59409) is from the tip area forward approximately six feet and has lower skin pieces attached. Many leading edge components are attached to the

spar personnel pass through locations with attached structural doublers and small pieces of the upper wing skin splice plates.

outboard/forward side including RCC fittings, spar insulators and access panels. There are localized areas of heavy slag build up and thermal erosion on the IML side.

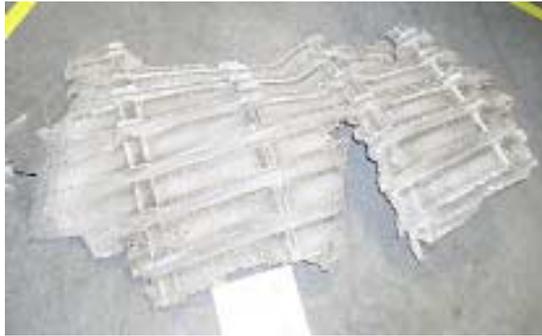
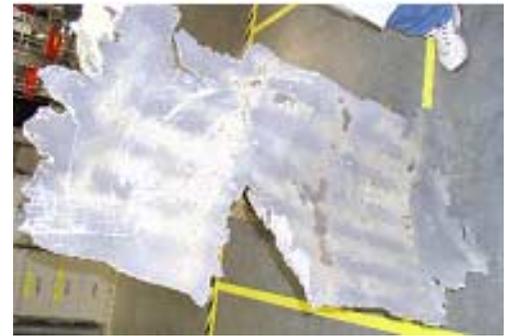
Item 76275

Left Hand Torque Box – Less than five percent of each of the upper and lower torque box surface areas were recovered. The pieces are less than one square foot in surface area except for two large skin pieces greater than five square feet. One of the large skin pieces located at Xw1220 and Yw147 to Yw183 (76275) is comparable to a right hand piece (71706)

that is in approximately the same location and has approximately the same size. The right hand piece remains relatively flat as compared to the left hand piece, which is bent out of plane in several locations. Although the left hand and the right hand pieces have similar thermal effects based on coloration and slag, the left hand hat stringers have more thermal erosion on the IML. The other large skin piece is from Xw1249, Yw312 to Yw372 (49443) and is comparable to a right hand piece (2287) that is smaller in size and in approximately the same location. In this case the left hand piece also exhibits more heat effects than the right hand when based on coloration, slag, and thermal erosion of the hat stringers on the IML. The remaining smaller items are pieces of upper wing skin splice plates at main spar locations. The recovered pieces of left hand Xw1365 splice plates have a much larger slag build up than the right hand Xw1365 splice plate pieces.

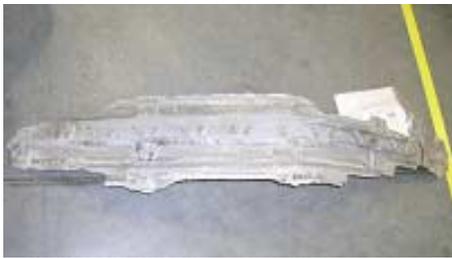
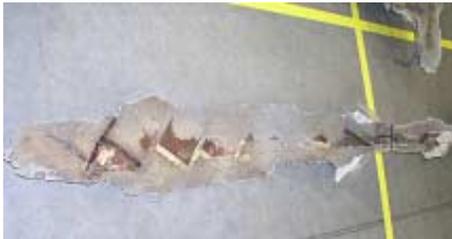
Item 52816

(52816) was recovered that has a medium slag build up on the IML. This piece, although smaller in size, is comparable in location to a piece on the right hand side (2071) which has no slag present, and little primer discoloration. A total of five pieces of the Xw1307 splice plate were recovered. One piece at Yw372 (71799) Item 71799 includes a reinforced hoist point area and

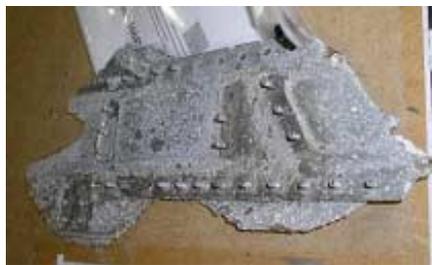
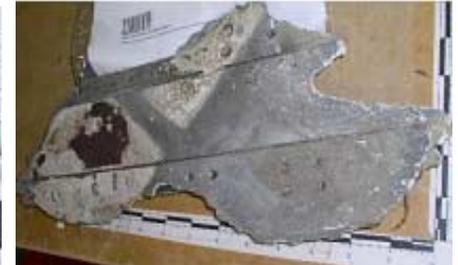
Item 16647

The lower skin pieces recovered in the torque box were located outboard of Yw256, except for one, and attached to wing skin splice plates at main spar locations. The piece inboard of Yw256, the Xw1249 splice plate at Yw167 (16647), has medium slag on the IML.

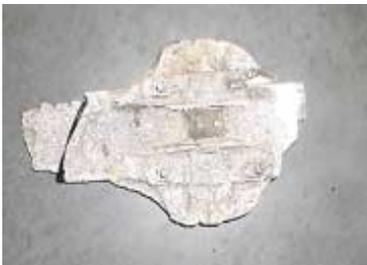
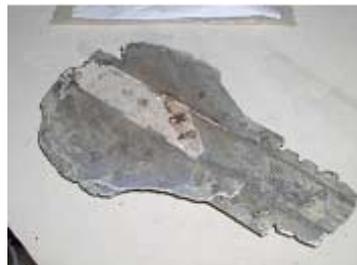
Item 71799

has heavy slag on the IML side and is comparable to a right hand piece (33194) that is larger but from the same location. The left hand piece has more heat effects than the right hand piece when based on coloration, slag, and thermal erosion on the IML.

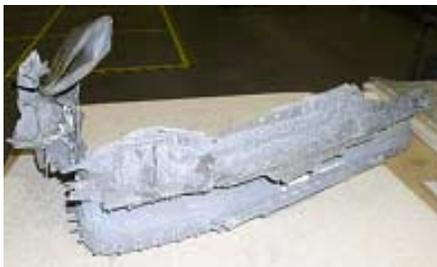
Item 73945

Two pieces of the Xw1365 splice plate were recovered that had medium slag on the OML. One located at Yw335 (73945)

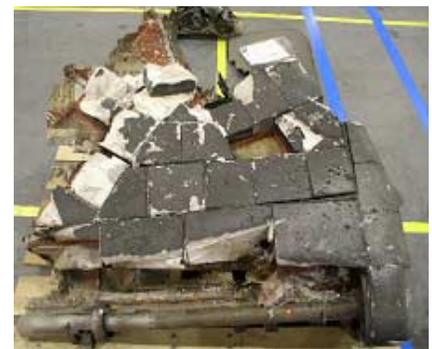
Item 780

The largest recovered piece was the left hand wing tip (780), which contained several elements including the outboard section of the primary seal tube, lower wing skin sections, wing tip installation, wing trailing edge beam, and a small portion of the wing leading edge honeycomb spar. The OML surfaces of the wing tip piece are less affected by heat than the IML surfaces, which have heavy slag deposits on the forward facing surfaces.

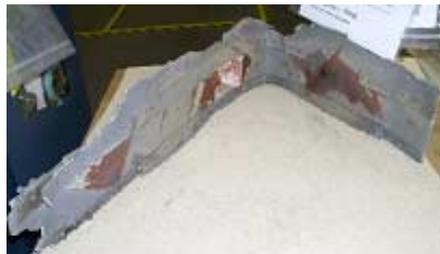
Item 67481

Thirty percent of the wing trailing edge lower surface area was recovered with most skin pieces attached to the Xw1365 splice plates. The area outboard of the Yw312 wing stub had fewer recovered pieces than inboard of Yw312. Approximately 70% of the wing trailing edge carrier panels were recovered and in every case the wing trailing edge beam structure fracture edges were approximately equivalent to the footprint of the carrier panel (67481).

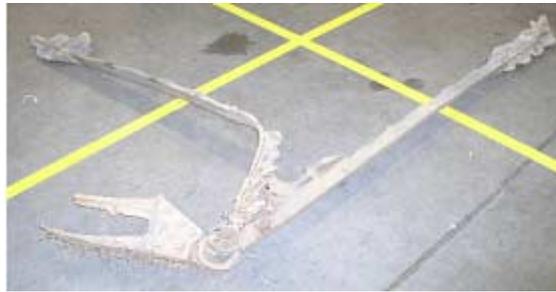
Item 56265

The other recovered pieces consist of narrow pieces of honeycomb skins that are attached to a rib on the IML side with a minor presence of slag. A piece of the Yw212 elevon hinge rib (56265, 7.5 Trailing Edge/ Cove) is attached and fractured approximately eighteen inches aft of the

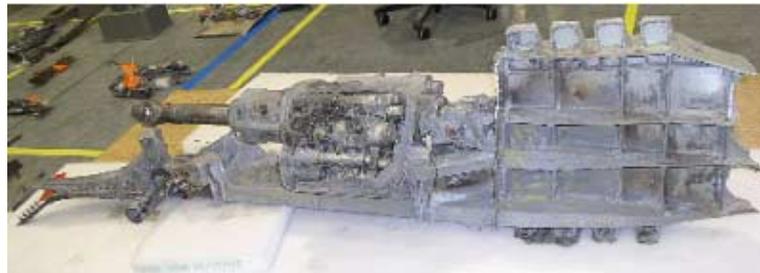
Item 44937

The Yw312 wing stub between the inboard and outboard elevon, the Yw212 hinge point for the inboard elevon, and the Yw387.5 hinge point for the outboard elevon were recovered. The Yw312 wing stub (44937) has a fracture edge approximately fifteen inches forward of the hinge point. The fracture edges are out-of-plane with broomstraw fractures. The outboard surface of this piece of wing stub has heavier slag than the inboard surface. The Yw212 hinge rib piece (56265) is seventy inches long and runs fwd from the hinge point with the fwd fracture edge

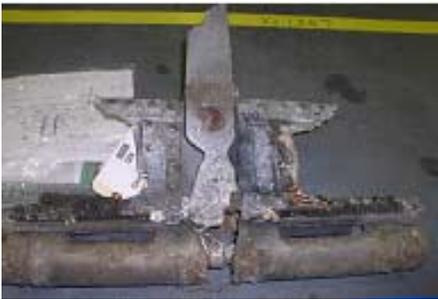
Item 1204

7.4 Torque Box) from Yw435 to Yw465. Additional pieces of the primary seal tube splices were attached to the wing hinge fittings at Yw342, Yw312, and Yw212. The Yw342 wing hinge fitting (1204) has heavy slag and thermal erosion on the lower surface directly through the splice tube. This thermal erosion also was also present on a recovered Yw435 right hand wing hinge fitting (1151).

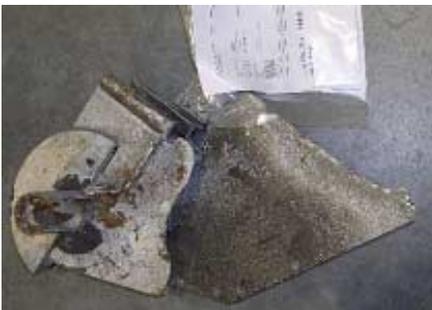
Item 44446

The Yw312 wing stub (44446) has a fracture edge approximately fifteen inches forward of the hinge point. The fracture edge is out of plane with broomstraw effects. The outboard surface of this piece of wing stub has heavier slag than the inboard surface. The thermal effects on this piece were of the same magnitude as a comparable right hand piece (44937), which also has the heaviest slag on the outboard side. The Yw212 actuator (7327) was recovered and had a hole through the outer casing on the upper fwd surface caused by thermal erosion. Its corresponding hinge rib piece (279) is forty inches long and runs forward from

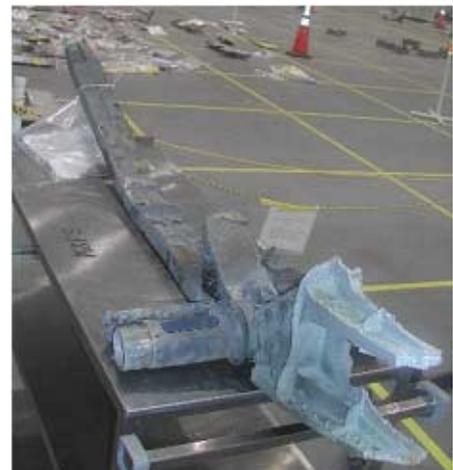
Item 279

the hinge point has a forward fracture edge where the rib attaches to the lower skin. The lower rib cap appears to have the original contour and the upper rib cap is fractured eight inches forward of the hinge point. The web and rib caps have thermal erosion and broomstraw fractures.

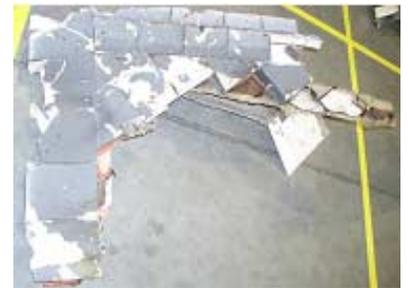
Item 71626

Left Hand Inboard Elevon – Five percent of the upper surface OML and 35% of the lower surface OML were recovered. The larger recovered items were located along the aft edge, including the aft-inboard and aft-outboard corners. The other smaller recovered pieces consist of narrow pieces of honeycomb skins that are attached to a rib on the IML side. The twenty square foot aft outboard corner (20583), the adjacent outboard sidewall honeycomb closeout (87) and the aft inboard corner (71626) were recovered. On the two corner pieces the upper OML TPS was missing, except in the trailing edge

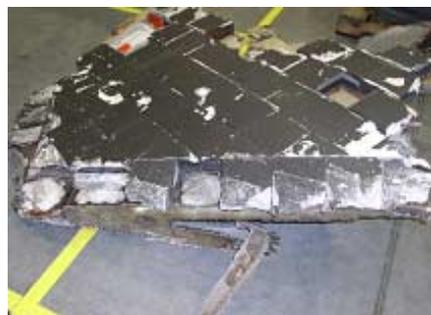
Item 20583

The largest piece was the aft outboard corner (35) that is forty square feet and has medium slag on IML fittings and ribs with broomstraw fractures. The upper OML TPS was missing, except in the trailing edge area, and there is thermal erosion of the honeycomb facesheet and core with broomstraw fractures. The lower OML tile has debris peppering and light gray discoloration compared to the inboard elevon piece (20583), and has many tile or tile fragments attached.

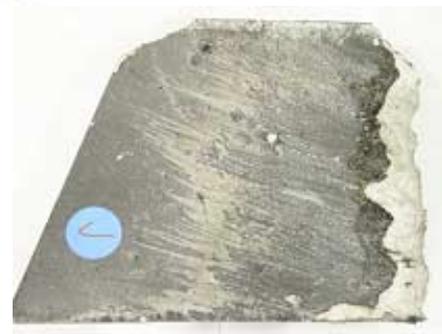
Item 33590

The majority of tiles identified in the MLGD region are concentrated around the perimeter of the outboard edge of the gear door. One tile, (33590), located on the outboard forward corner of the door has excessive heating. The erosion patterns

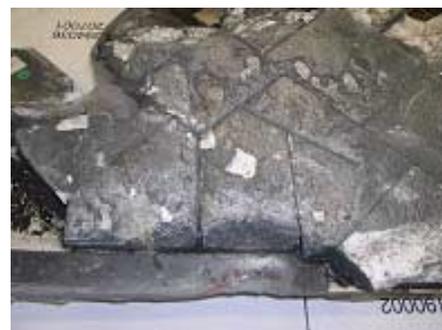
Item 283

show the flow direction starting from the IML to OML, moving inboard. The midbody structure side, inboard of the MLGD, has 6 tiles (283) with black deposits on the OML. The silica and Reaction Cured Glass (RCG) coating erosion patterns have a thermal erosion signature of an inboard flow direction. The remaining tiles on the gear door have minimal thermal degradation or contamination, with less backside heating effects as compared to the rest of the lower wing.

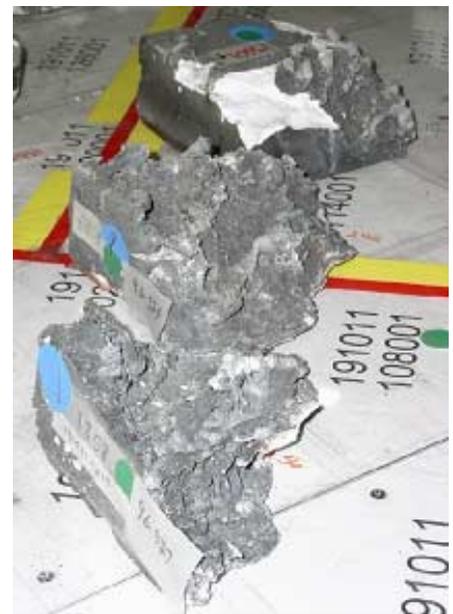
Items 43820, 13001, 1858

Three tiles (43820, 13001, 1858) located inboard of LESS access panel 13 have very unique erosion patterns. These patterns indicate RCG coating was damaged due to a debris impact, which not only exposed the underlying silica but also removed an entire portion of the tile. The remaining silica is severely glassified, but shows a normal reentry directional flow pattern. These features indicate the tile remained bonded to the structure for a substantial period of time during reentry. The remaining silica has embedded aluminum oxide, which is black in appearance.

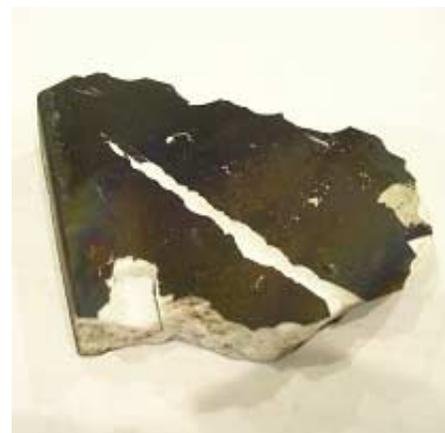
Item 14768

The most western recovered tile (14768) found in the debris field was a piece

of upper wing LRSI tile, with black deposits covering the OML. The tile piece was not positively identified, however 3D evaluation and lab analysis indicated the tile could be placed in one of two locations. Both possible locations on the left and right wing are inboard of Leading Edge Structural Subsystem (LESS) upper wing access panels 8 and 9.

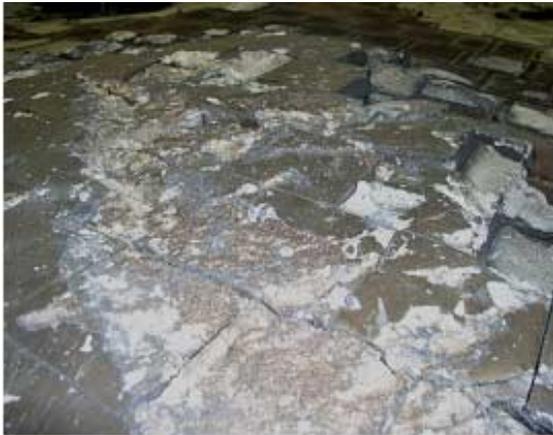
Item 658

On the lower wing, from Xo1040 to Xo1191, the MLGD had the majority of bonded tiles and tile remnants. Thirty percent of the MLGD tiles (658) were still bonded and show some shallow OML debris and heating damages. Tiles in this location typically showed a light brown discoloration. The remaining exposed structure has primer slightly charred and peeling with RTV adhesive attached.

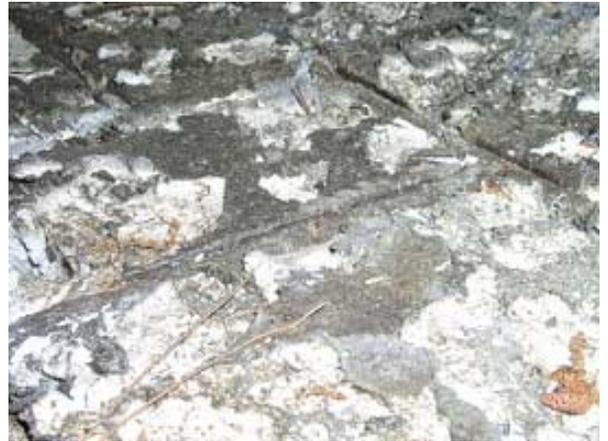
Item 75968

On the lower inboard and outboard elevons, unusual tile heating occurred on the outboard elevon, inboard edge. The OML Reaction Cured Glass (RCG) coating was separated from the underlying silica (75968). The remaining RCG coating was

pooled indicating airflow direction. The color of the RCG coating and silica are unusually discolored exhibiting a light brown gray appearance. The upper surface of the elevons are covered FRSI per design, of which the only recovered portion was on the upper outboard elevon.

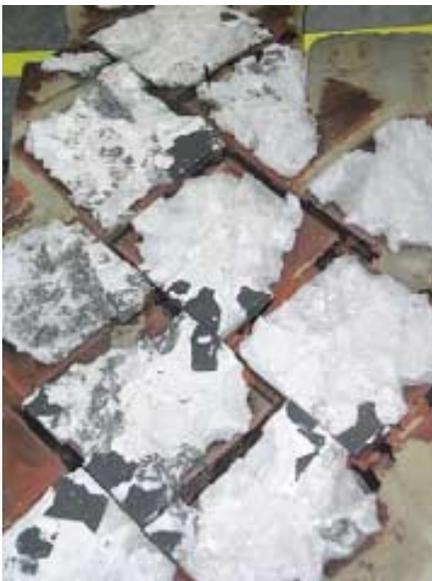
Item 28421

Tile failures on the upper wing were a combination of backside heating and in-plane fractures, however, no FRSI was recovered. Structure pieces with tiles still installed (28421 and 1412) are primarily located from Xo1191 aft, inboard from the spar edge. Tiles in this region are less than one-inch thick and were recovered with black deposits on the OML. One instrumentation tile (43000) was positively

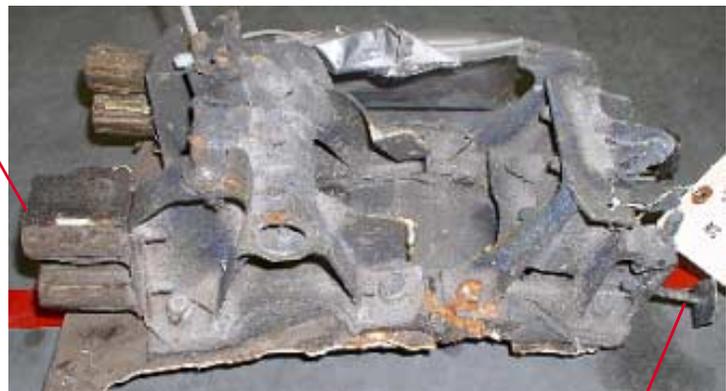
Item 36 LH Spar Fitting 21

Fewer upper than lower LESS access panels and/or tile were recovered and had more damage. Inspection of the LESS access panels attaching hardware shows thread engagement met design requirements. The primary failure mode for the lower panel attach is bolt pull through whereas the upper is honeycomb core pull through (36).

Upper core
pull through

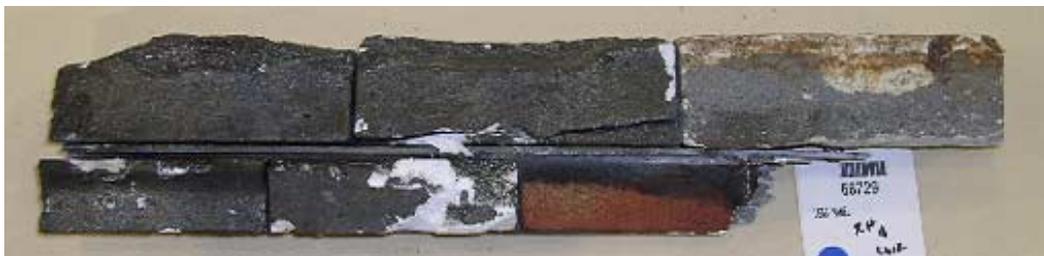
Item 68729, 75915, 80558

not recovered. The right hand upper and lower spar fittings for rib splice 4 were not recovered. There are pieces of the aluminum wing spar attached to the spar fittings. The fittings and outer facesheet of wing spar have a non-uniform splattering of molten aluminum deposits

though the remaining pieces of silicone barrier on the spar are still pliable. The inner spar facesheet is virtually free of metallic deposits.

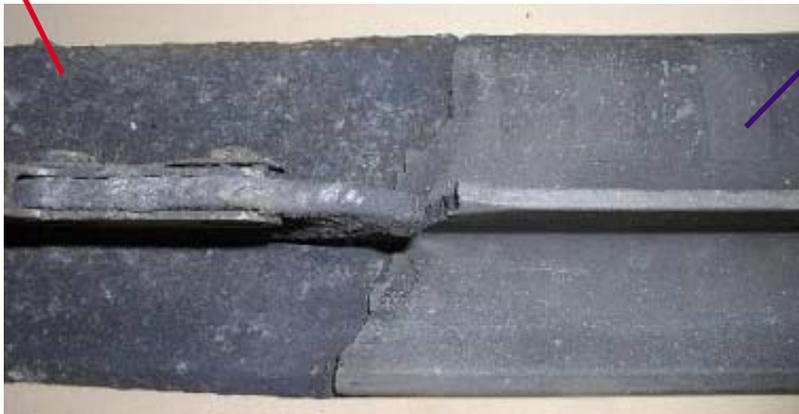
Items 58575, 18474

based on deposit levels. Panel 2 and its associated gap seal have a heavy concentration of metallic deposits on one side of a fracture while the mating fracture surface is completely free of deposits. This condition is found on the gap seal (64823, 58575, 18474) where the middle

section is free of deposits and the upper and lower portions have a heavy coating of deposits.

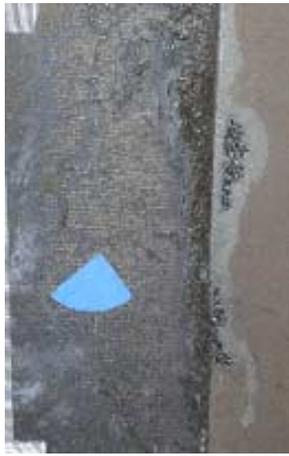
Item 64725

Gap seal 5 lower portion has tile coating transferred to the outer surface of the seal (64725). Similar tile deposition is also found on right hand gap seal 10 and 13.

A gap seal rotation test confirmed that a de-pinned (not fastened) upper attach point will allow the seal to pivot about the lower attach point. An apex region through crack in a gap seal is required to allow a portion of the gap seal to pivot about the upper attach point. This pivoting could allow contact with tile, thus transferring material.

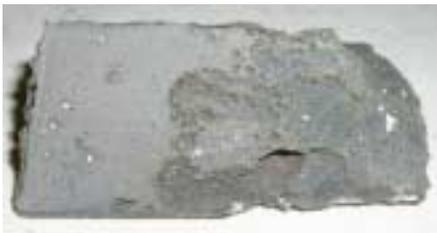
Item 50336

panels is consistent with the panels in the other regions. Each lower access panel location for left hand and right hand side is represented either by tile, panel or combination of the two. Three right hand upper access panels are represented, of which panel 10 is facesheet only. The upper left hand transition area is void of access panels and tiles with the exception of the inboard interior tile for panel 8 (50336). The tile exhibits radiant heating and has deposits of Inconel, aluminum, carbon and Cerachrome.

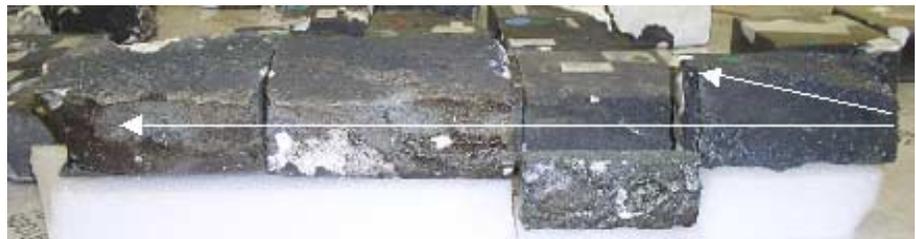
Panel 9 - Items 16692, 50338, 22571, 57754

There is no heat damage on any of the right hand panels. The only heat damage to the lower panels is to the tiles for left hand panel 9 (16692, 50338, 22571, 57754) on the surface adjacent to the RCC. Though the tiles exhibit severe heating, a portion of the aluminum access panel, as well as panel 8 and 10, survived with minimal heat effects.

The slumping and erosion of the tiles for panel 9 originates in the inboard forward corner, which aligns directly with the design notch in the heel of RCC panel 8 as shown above.

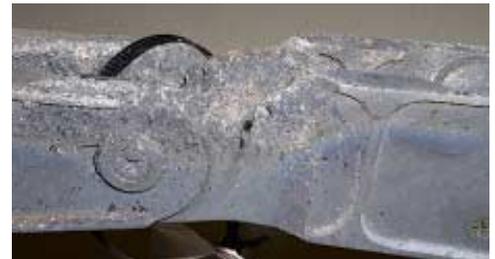
Item 55085

- Right hand 7 inboard & outboard (55085 & 32087)
- Right hand 8 outboard, two locations (66897)
- Left hand 7 inboard upper (83639)
- Left hand 11 inboard (70376)

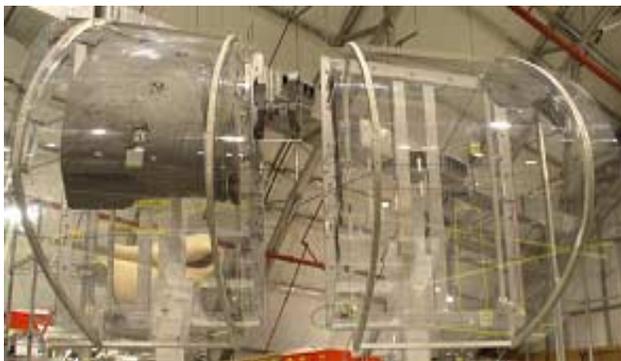
Left Hand RCC Panels 8 & 9

The lower acreage of left hand panels 8 and 9 are completely void of RCC material.

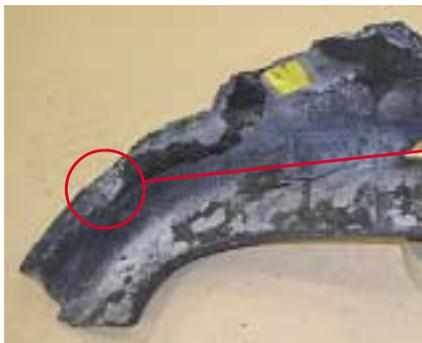
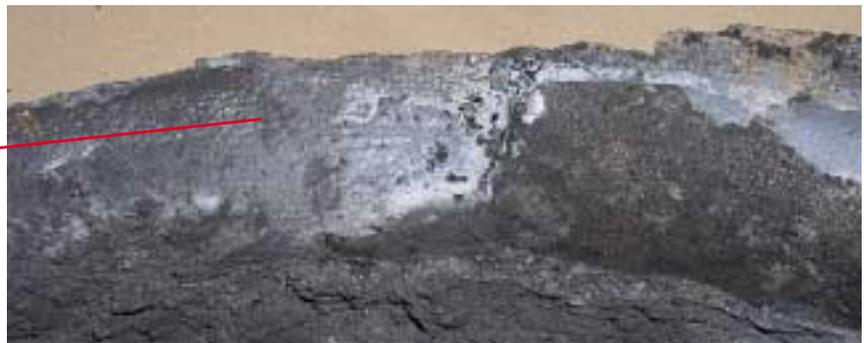
Item 1419

right hand wing. There is oxidation of RCC material on both wings. The outboard rib on right hand panel 8 has oxidation on the spar side of the panel (1419). The only erosion found on any of the RCC panels is the outboard rib and heel of left hand panel 8 and the inboard rib of left hand panel 9.

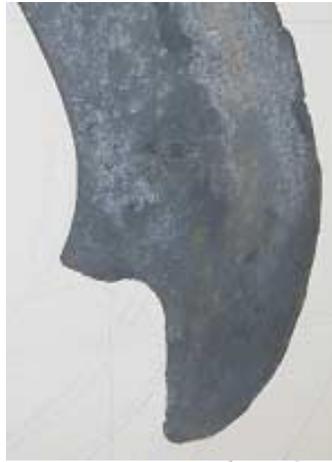
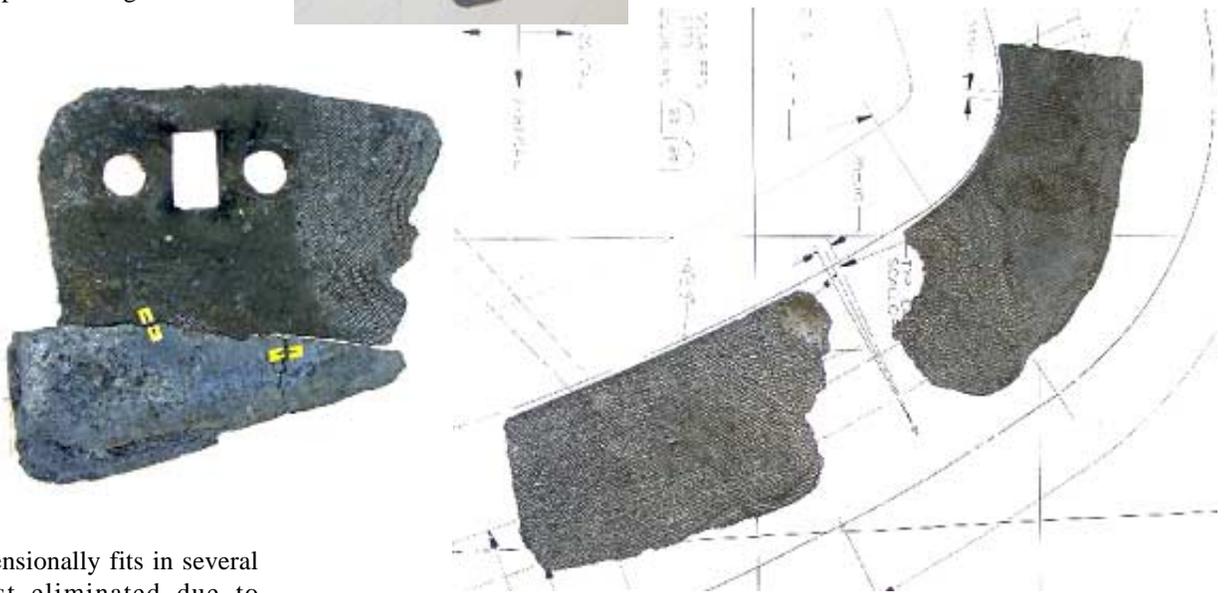
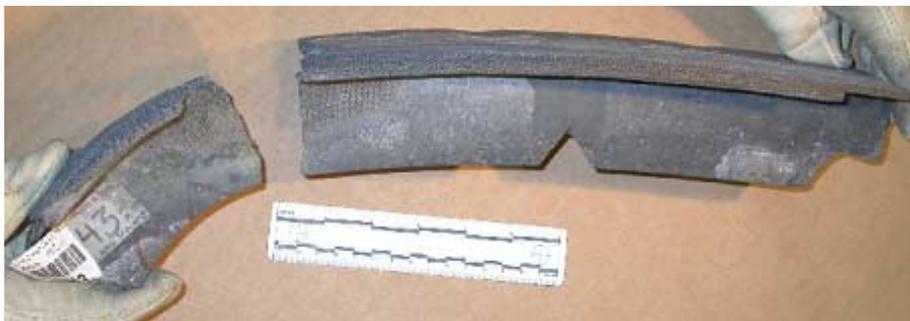
Items 17943, 35201

There are two pieces of left hand lower gap seal (35201, 17943) that still need location confirmation. Comparing wear, deposits, near fracture match and upstream erosion the pieces appear to be related.

The pieces dimensionally fits in several locations, most eliminated due to recovered items. The remaining locations

are rib splice 9 and 10. The best fit based on surroundings is rib splice 10. The erosion on the gap seal does not match the erosion on the ribs of the RCC panels at rib splice 9. The deposits on the seal pieces, does match the deposits on panel 11 at rib splice 10.
